**Sample Description:** Concrete cores, 2" diameter**Sample Condition:** suitable for analysis**Date Sampled:** August 10, 2022**Sampled By:** R.J. Allen, Inc**Sample Location:** 4615 E 4<sup>th</sup> Street, Long Beach, California**Job Name:** Bridgeport**Job No.:****Customer:** OXOH2O Solutions, Inc.

**Report No.:** 01130122**Analysis Completed:****Primary Analyst:** Thomas Holzheu

## INTRODUCTION

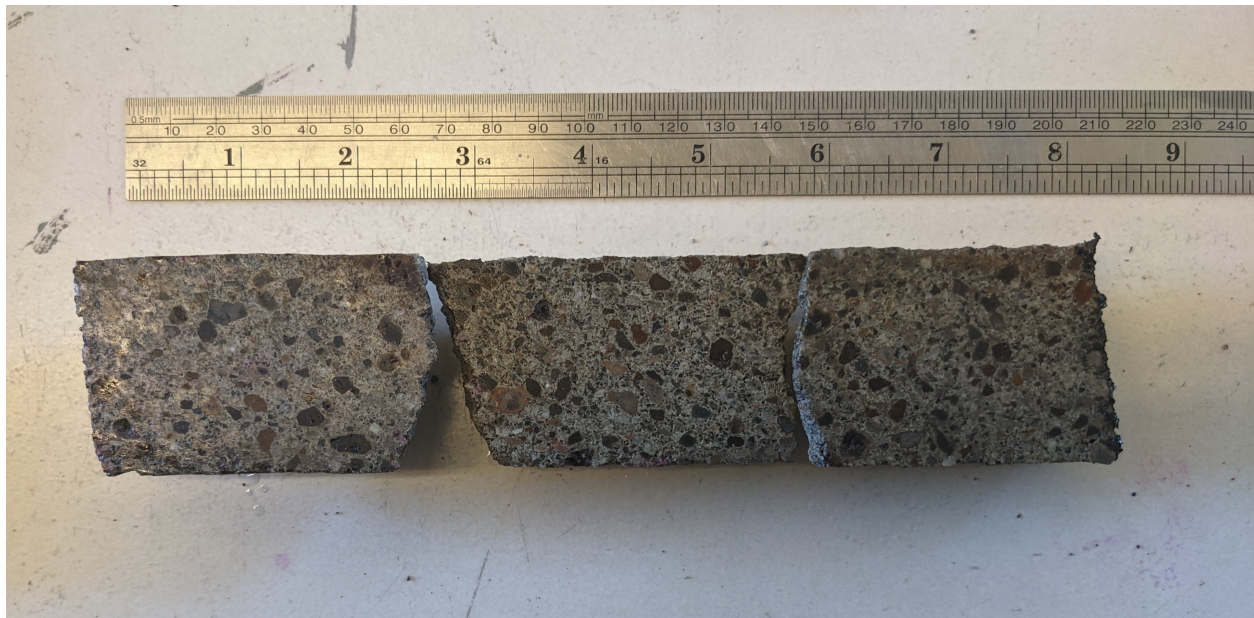
**Figure 2.** CMU reference core section after application of the phenolphthalein indicator (freshly cut cross section). No color change was observed, which indicates a pH <10 and carbonation of the cementitious paste has occurred throughout the CMU block.

The untreated reference core (B2) appears to be completely carbonated throughout the entire width of the CMU block (see Figure 2). Only the infill mortar/grout material still showed the pink indicator color (pH >12.5). For comparison, the phenolphthalein indicator turned pink on the OXO H<sub>2</sub>O treated CMU block (Figure 3) throughout the entire 8" length of the core, indicating the range of the treatment.

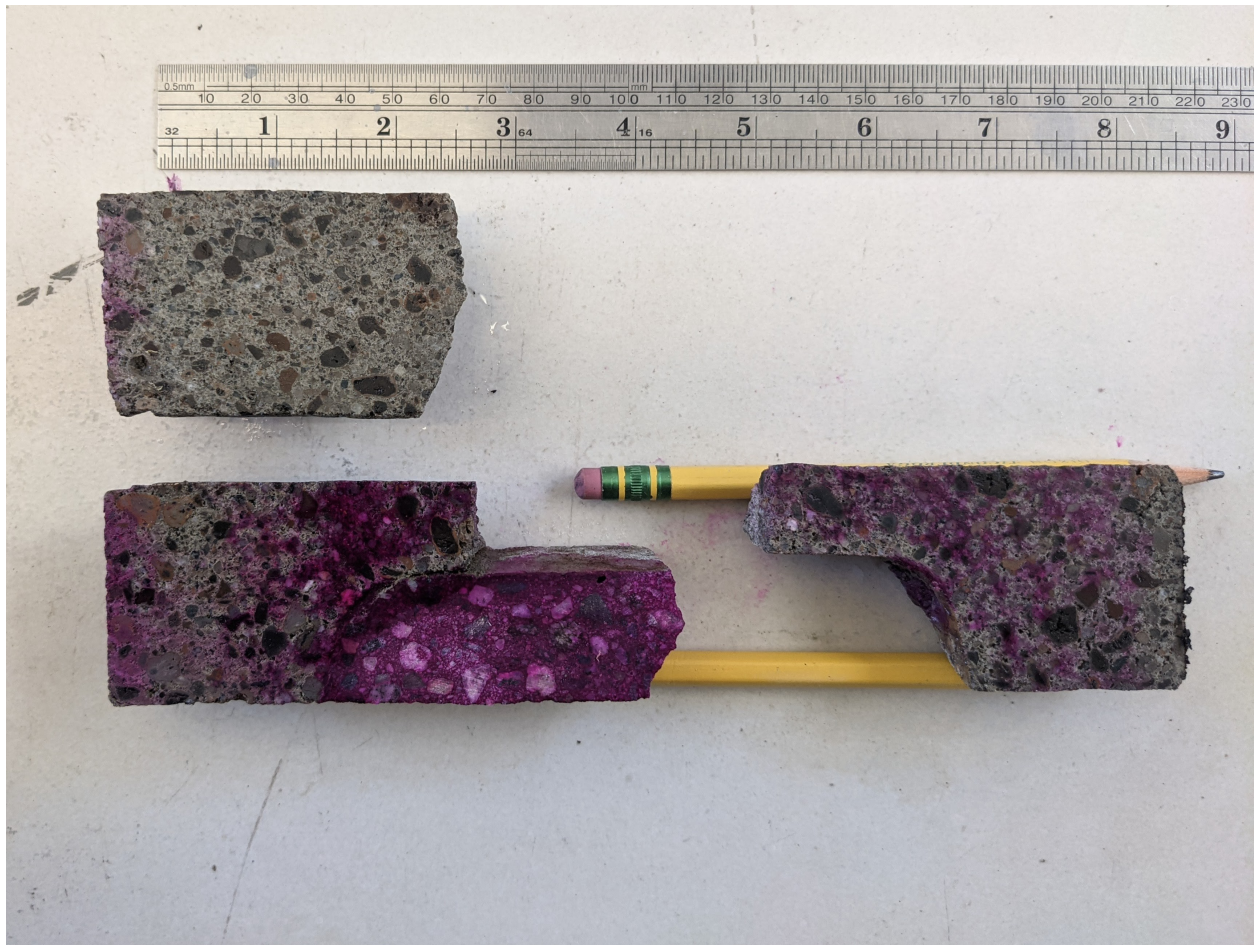
**Figure 3.** Comparison of freshly cut cross sections of the reference (top, B2) and the OXO H2O treated (bottom, A3) cores. The color change of the phenolphthalein indicator to pink is clearly visible throughout the treated CMU core (A3).

The phenolphthalein indicator tests demonstrates the range to the full 8" length of the CMU block of the OXO H<sub>2</sub>O treatment (see Figure 3). The appearance of the staining pattern would suggest a increase of the pH value (>12.5) of the pore solution in the connected capillaries and voids. The elevated pH of concrete facilitates a protective envelop of embedded rebar elements and is one factor in preventing rebar corrosion.
